# Inspection Report

*This inspection performed in accordance with current "Standards of Practice" of the California Real Estate Inspection Association.*

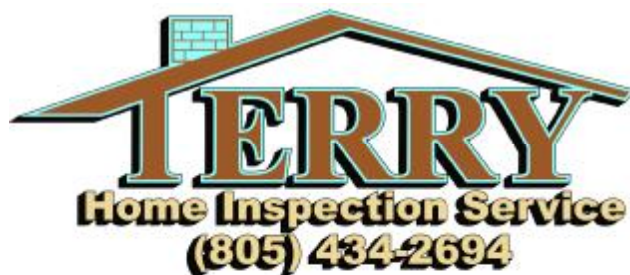
## **Table of Contents**

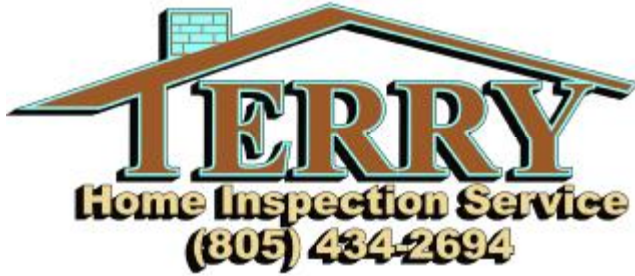
PROPERTY / CLIENT INFORMATION

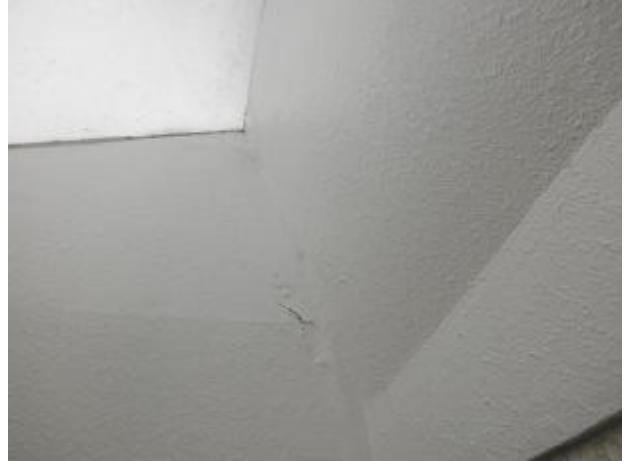
**Evidence of leaks at the skylight.**

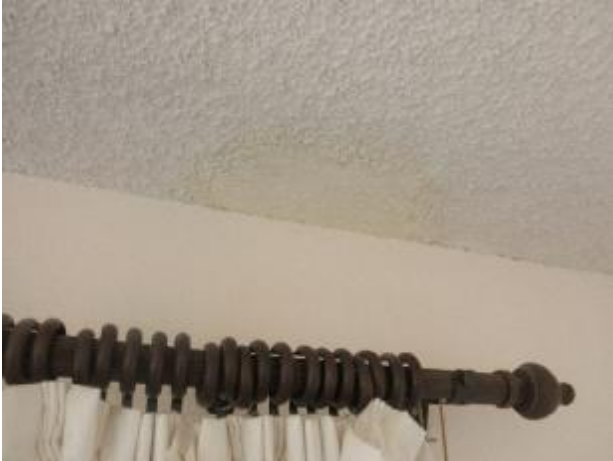
**Evidence of leaks in the master bedroom.**

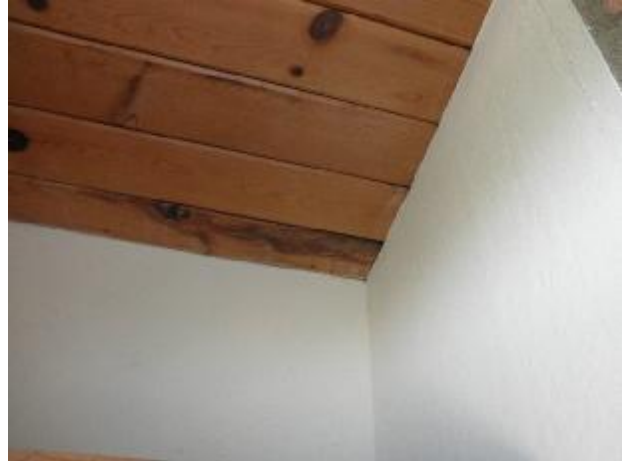
**Evidence of leaks in the living room.**

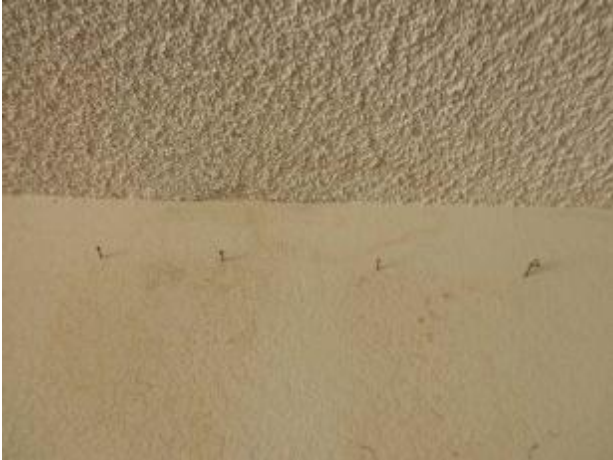
**Evidence of leaks in the garage.**

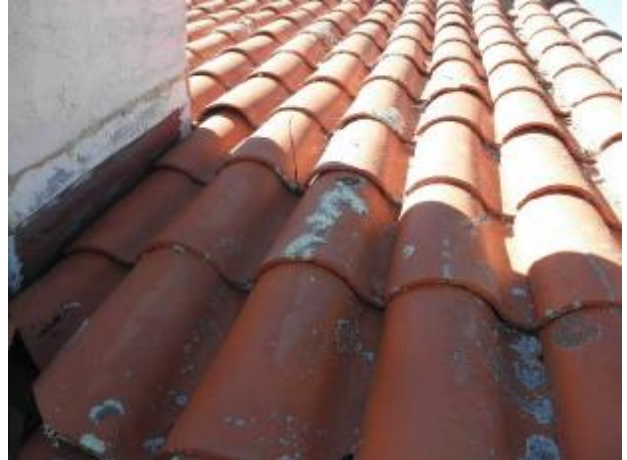
**Example of the cracked and broken roof tiles.**

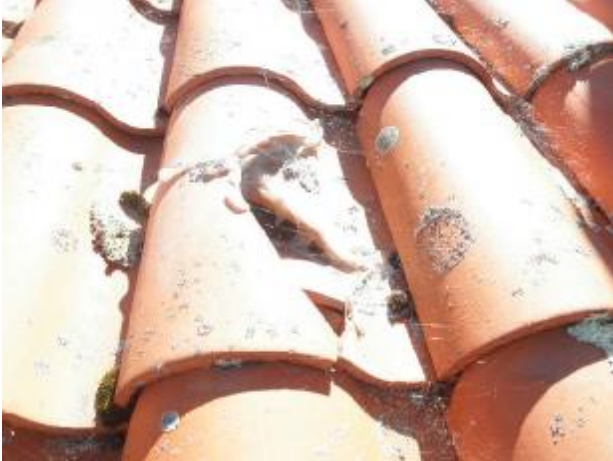
Example of the cracked and broken roof tiles.

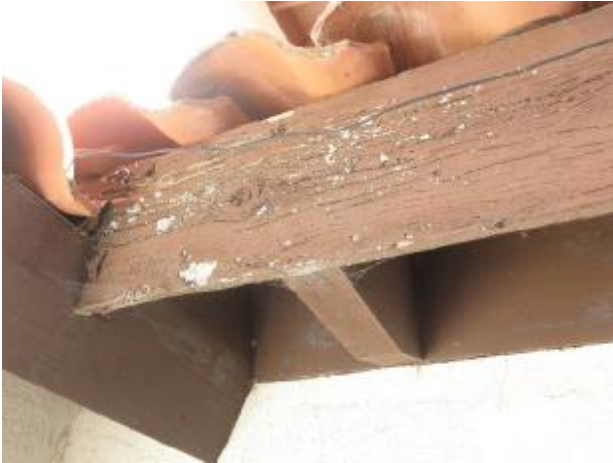
**Example of the moisture and termite infestation/damage at the exterior eaves.**

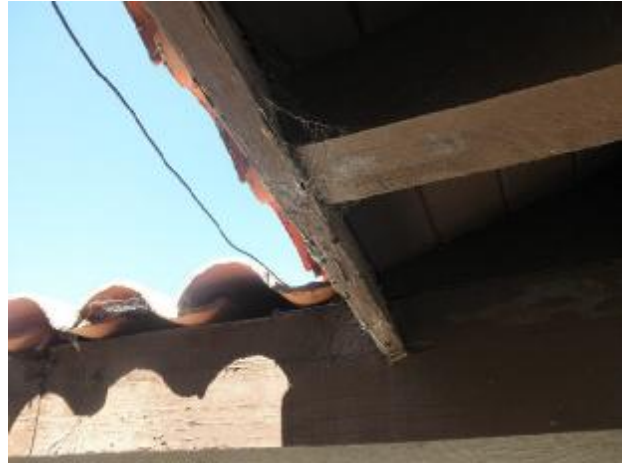
**Example of the moisture and termite infestation/damage at the exterior eaves.**

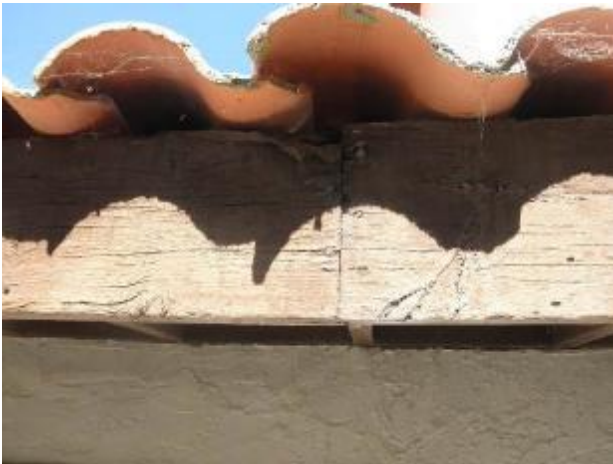
**Example of the moisture and termite infestation/damage at the exterior eaves.**

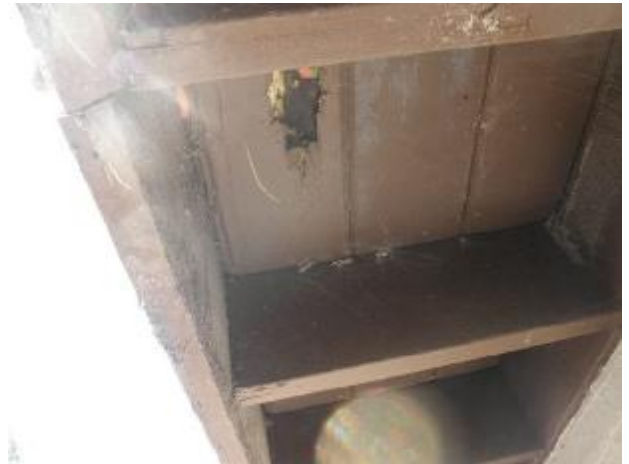
**Example of the moisture and termite infestation/damage at the exterior eaves.**

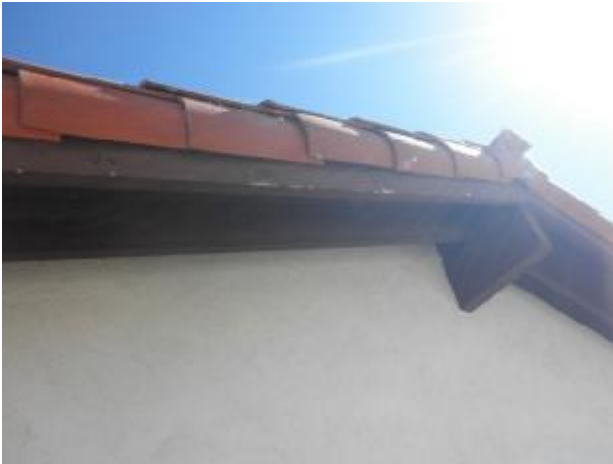
**Example of the moisture and termite infestation/damage at the exterior eaves.**

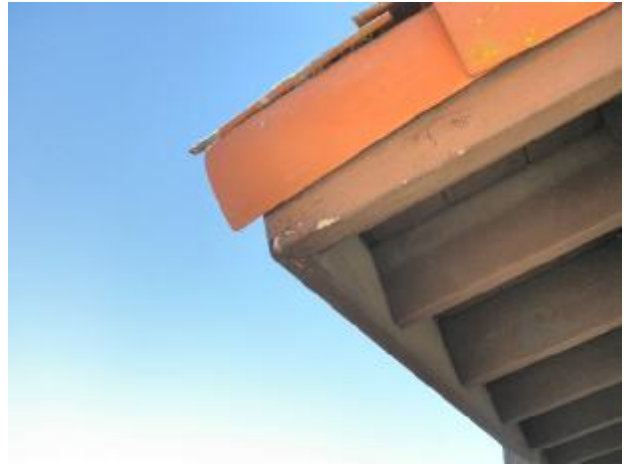
**Example of the moisture and termite infestation/damage at the exterior eaves.**

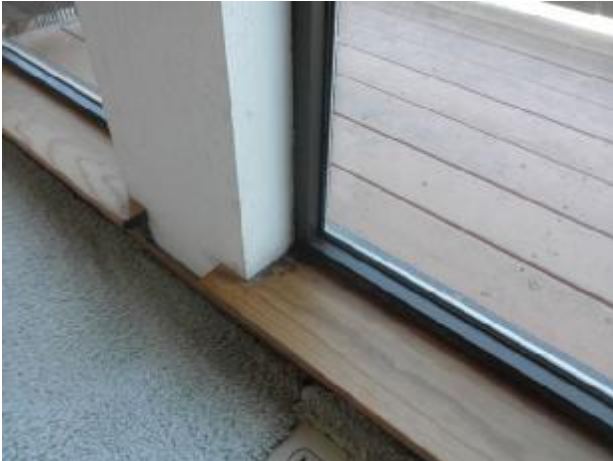
**Evidence of leaks at the large fixed windows in the living room.**

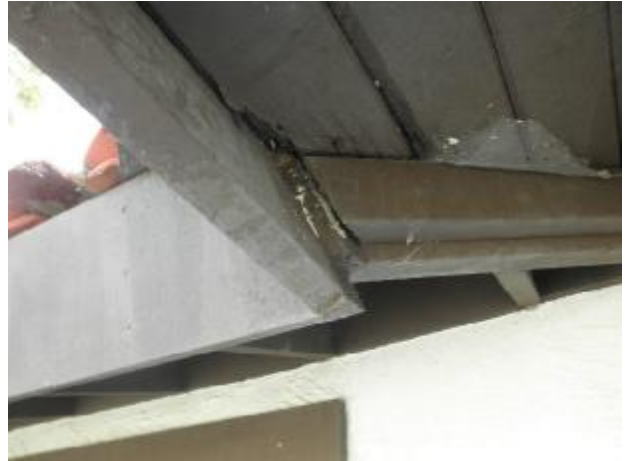
**Example of the moisture and termite infestation/damage at the exterior eaves.**

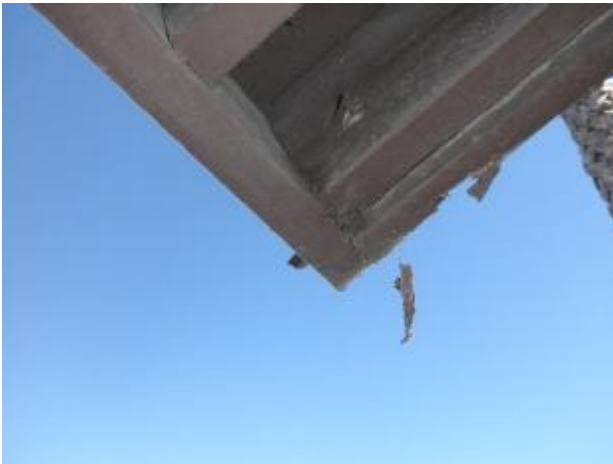
**Example of the moisture and termite infestation/damage at the exterior eaves.**

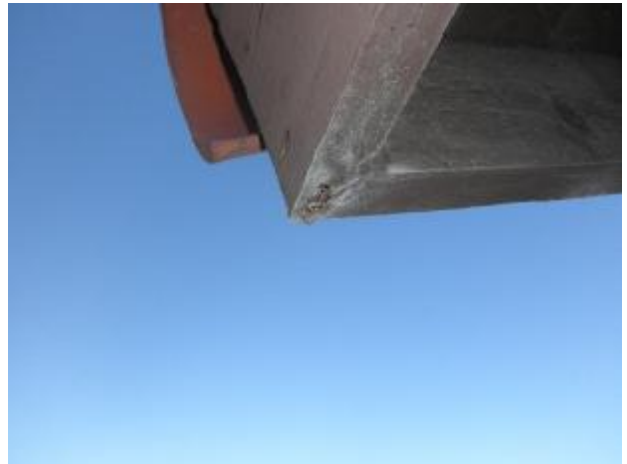
**Example of the moisture and termite infestation/damage at the exterior eaves.**

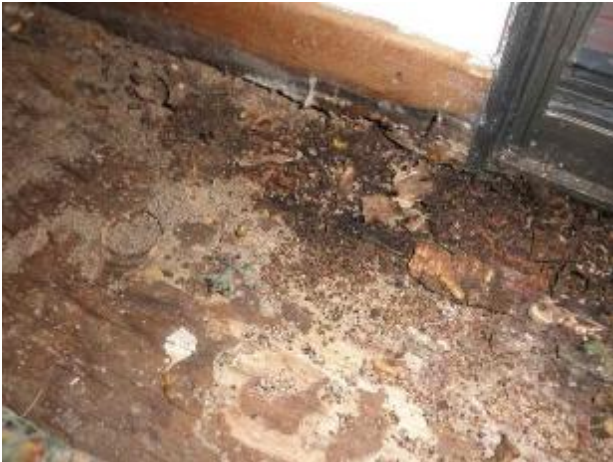
**Leaks with moisture and bug damage to the interior subflooring by the sliding glass door in the mas. bed**

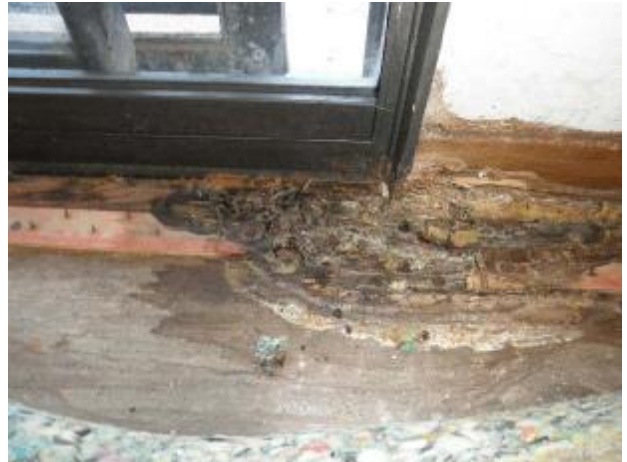
**Leaks with moisture and bug damage to the interior subflooring by the sliding glass door in the dining rm.**

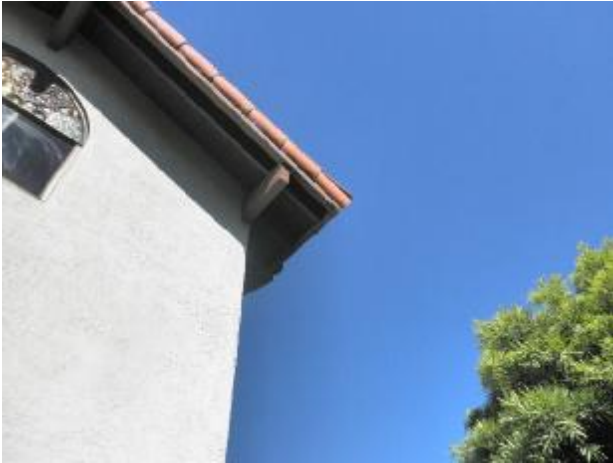
**Example of the moisture and termite infestation/damage at the exterior eaves.**

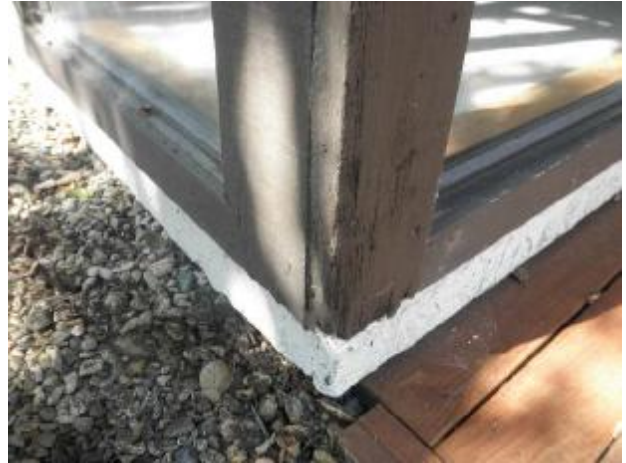
**Moisture damage at the base of the exterior walls in the sun room.**

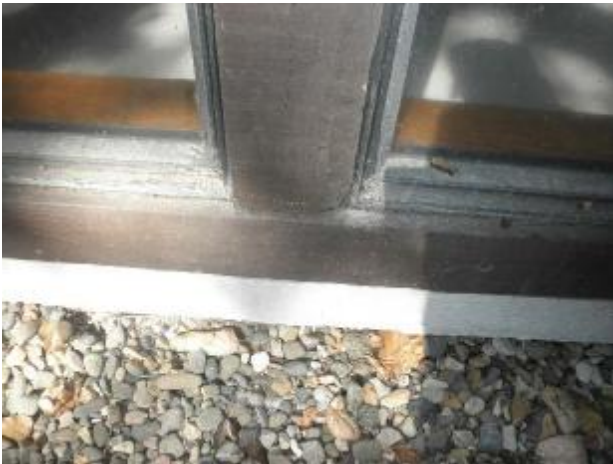
**Moisture damage at the base of the exterior walls in the sun room.**

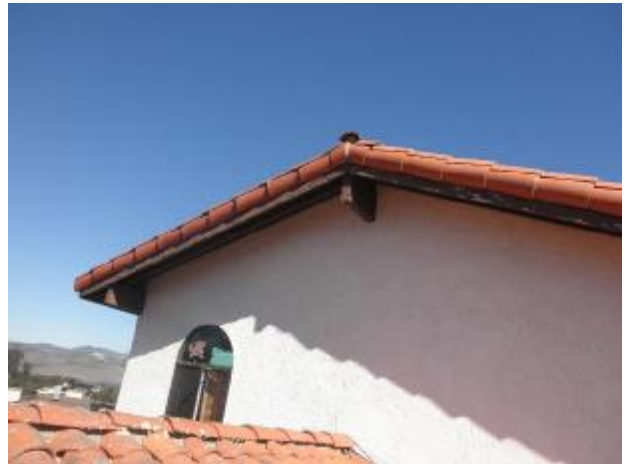
**Example of the moisture and termite infestation/damage at the exterior eaves.**

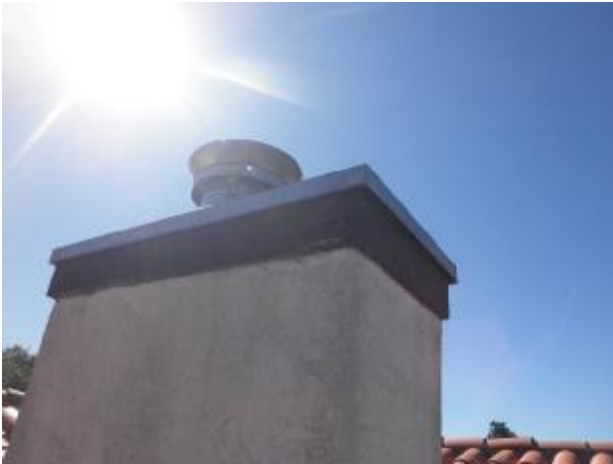
**Moisture and termite damage to the wood trim at the top of the chimney enclosure.**

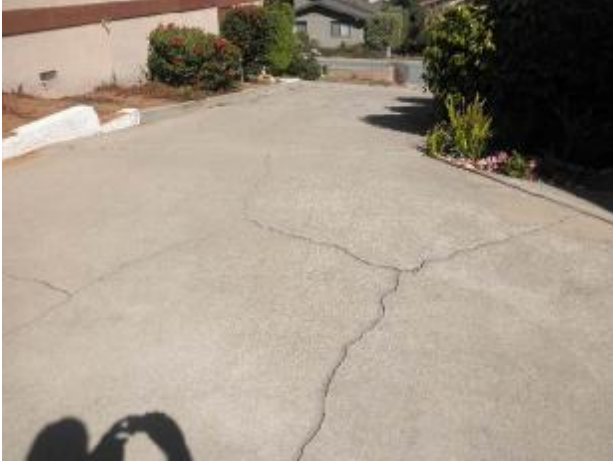
General settlement cracks in the concrete driveway.

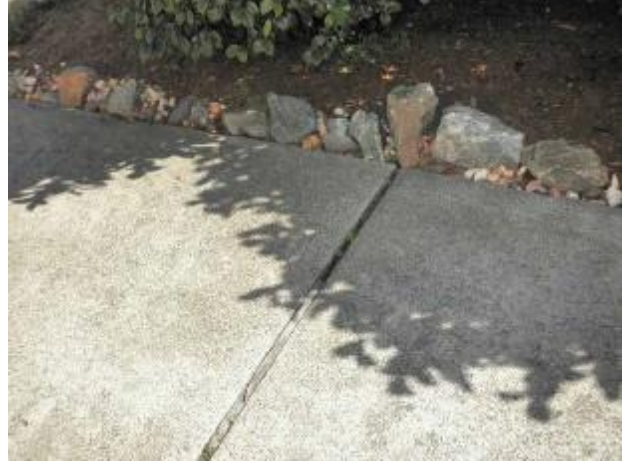
Damaged and missing wood spacers in the concrete driveway.

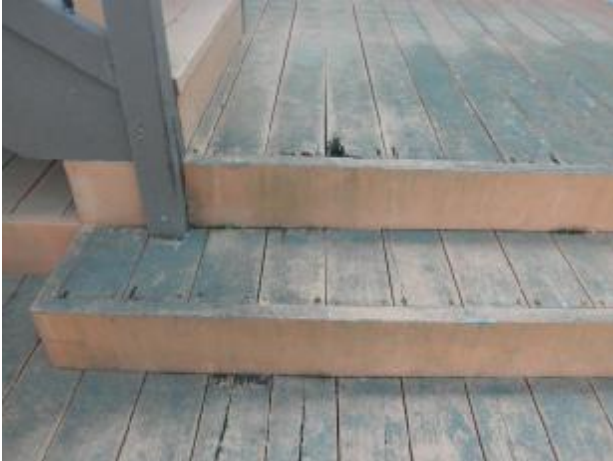
Example of the moisture and termite damage at the site decks.

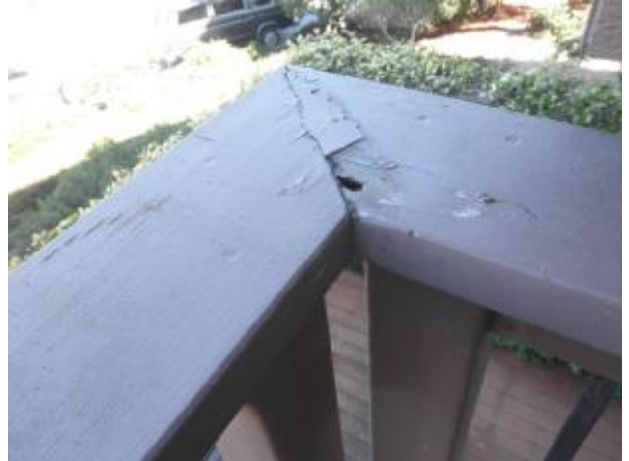
Example of the moisture and termite damage at the site decks.

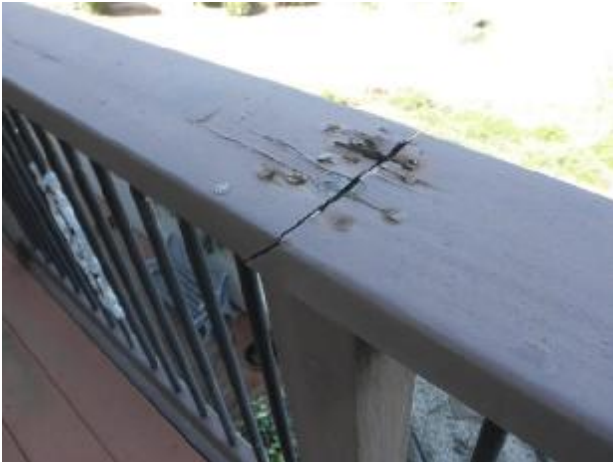
Example of the moisture and termite damage at the site decks.

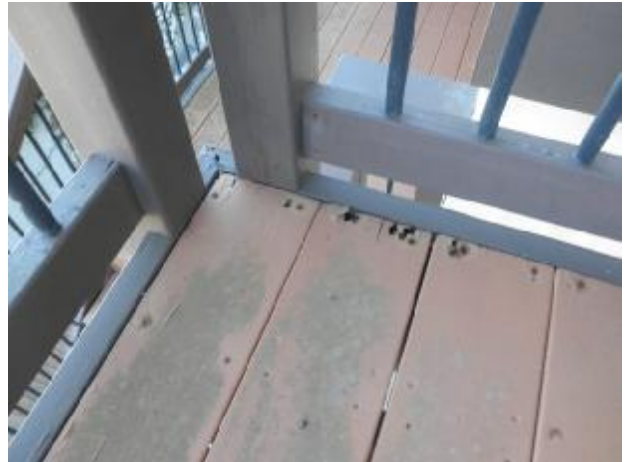
Example of the moisture and termite damage at the site decks.

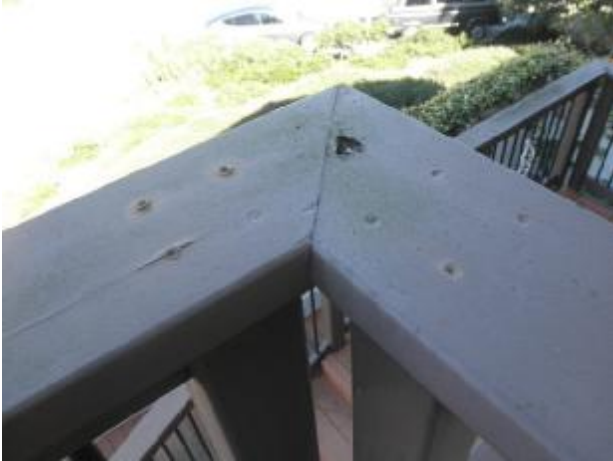
**Example of the moisture and termite damage at the site decks.**

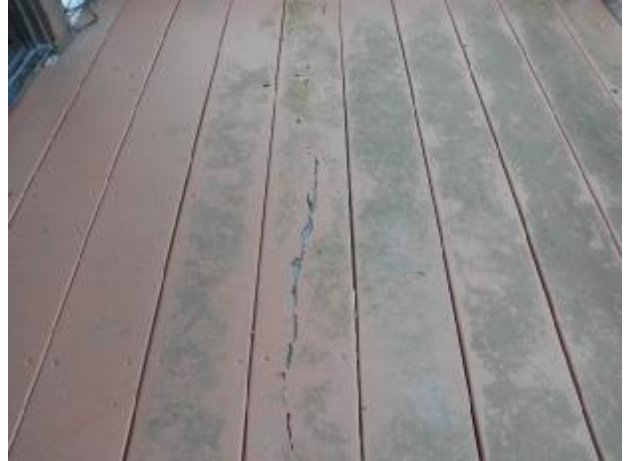
**Example of the moisture and termite damage at the site decks.**

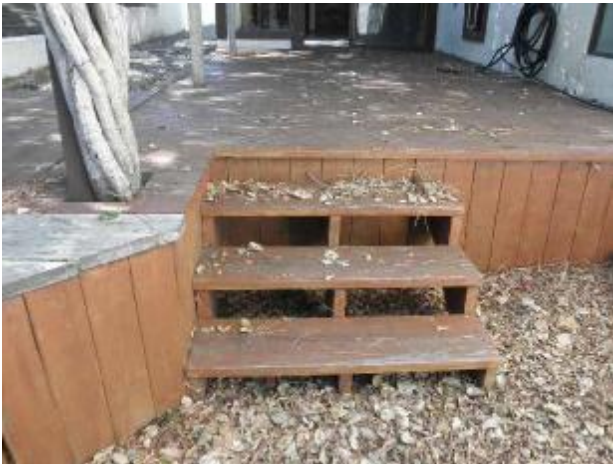
**Missing railing at the backyard deck stairs.**

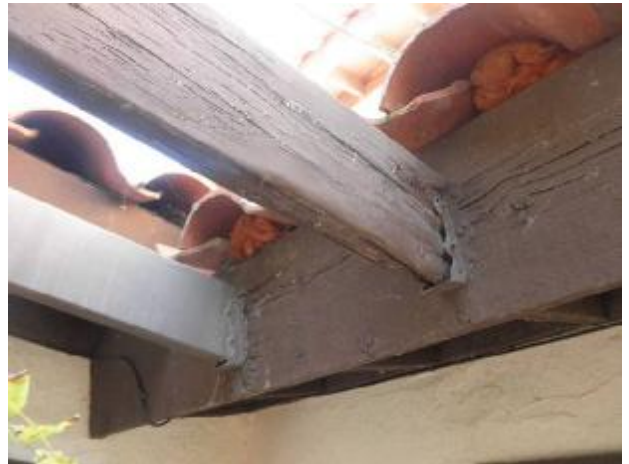
**Moisture damage to the framing at the pergola.**

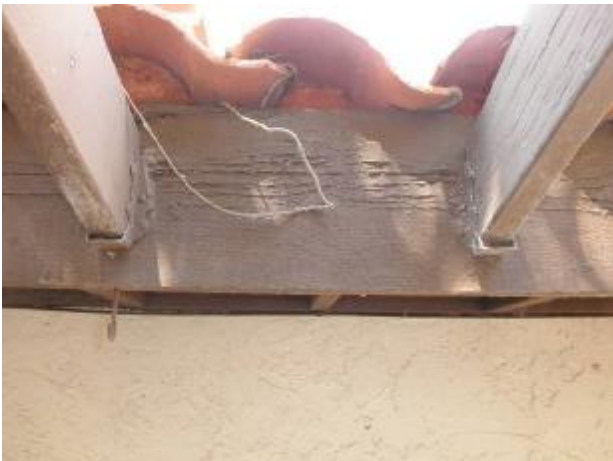
**Moisture damage to the framing at the pergola.**

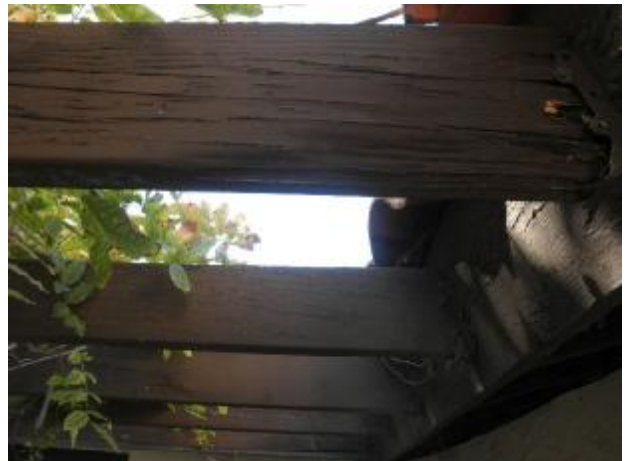
**Moisture damage to the framing at the pergola.**

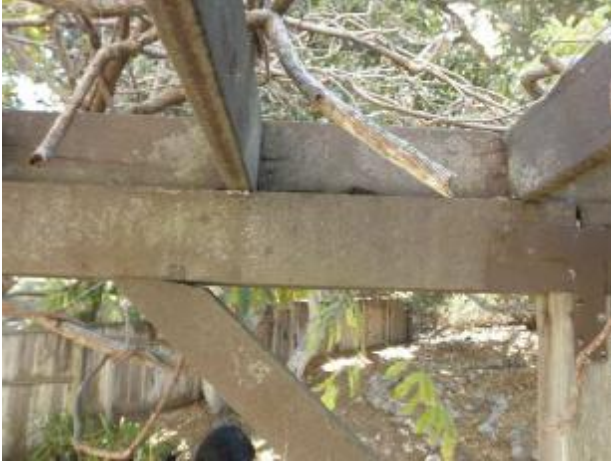
**Moisture damage to the framing at the pergola.**

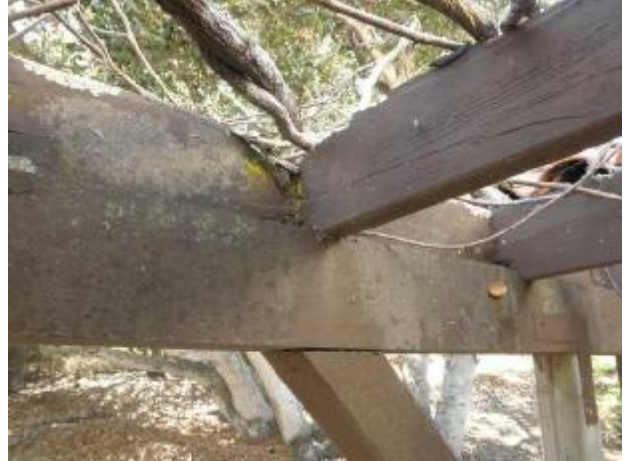
**Moisture damage to the framing at the pergola.**

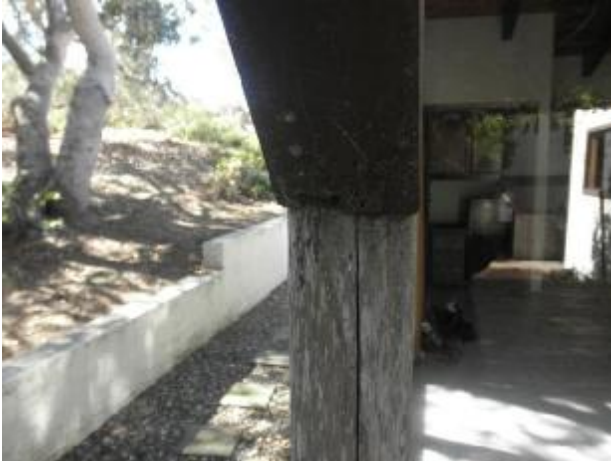
**Moisture damage to the framing at the pergola.**

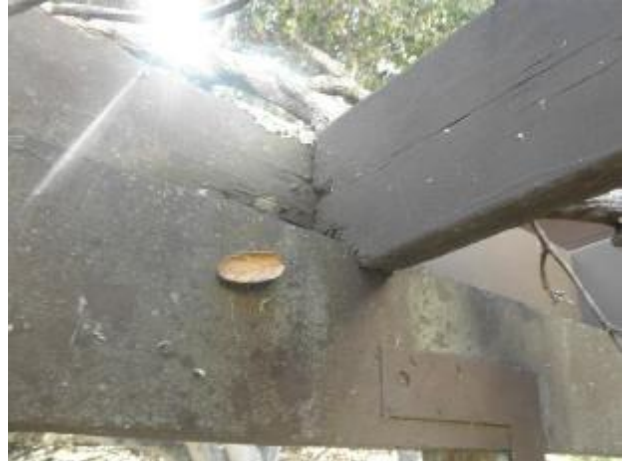
**Moisture damage to the framing at the pergola.**

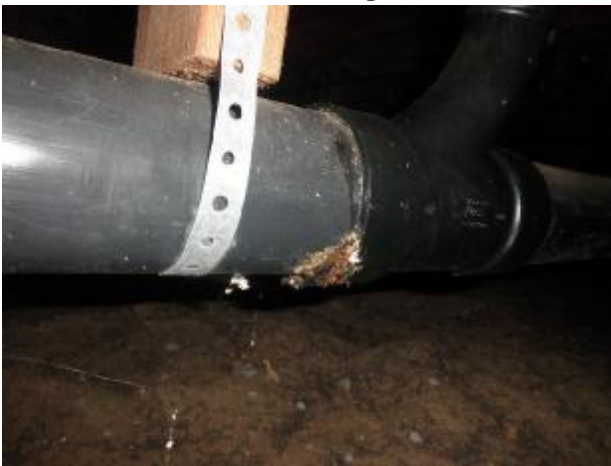
Leak at the drain waste line in the substructure area.

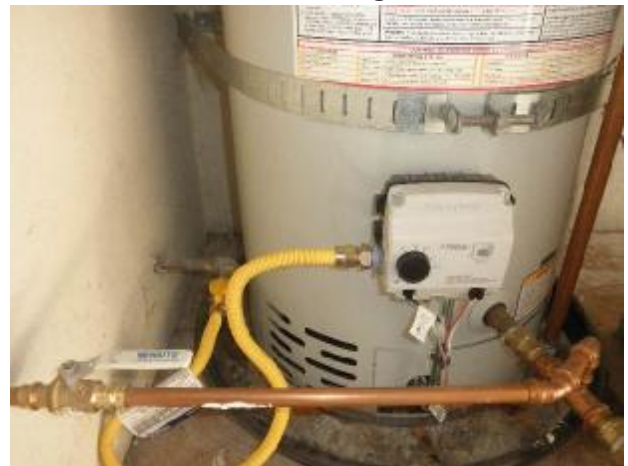
Missing sediment trap at the gas line connection to the water heater.

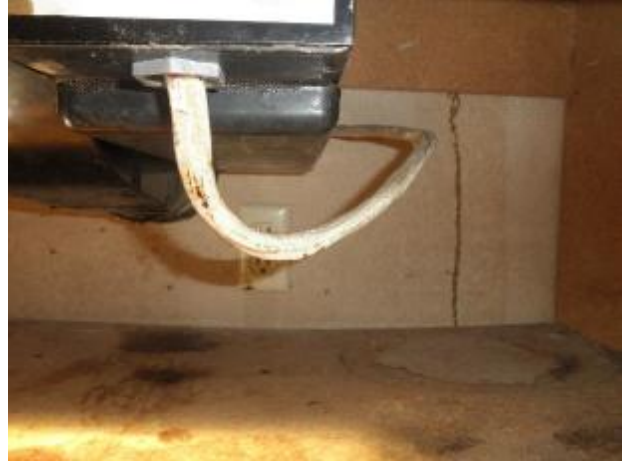
Missing conduit at the Romex wiring in the cabinet below the kitchen range.

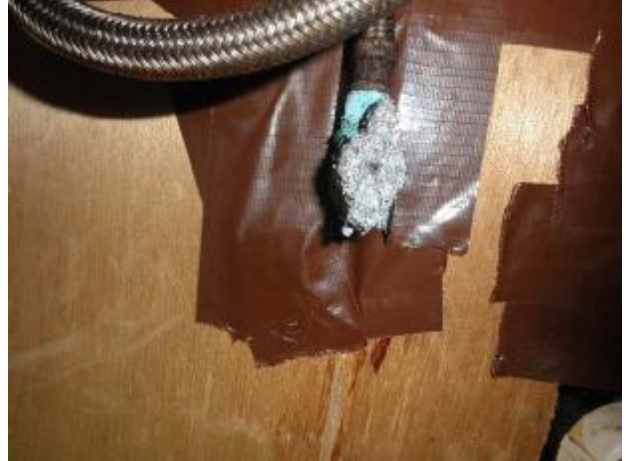
Excessive corrosion on the angle stop valves below the sink in the hall bathroom.

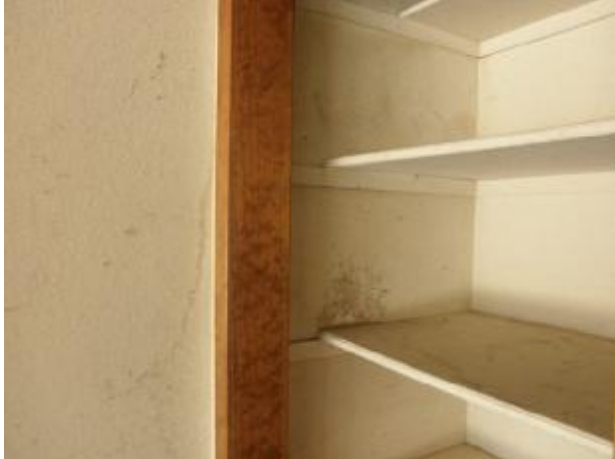
**Evidence of leaks with a black mildew like substance on the drywall inside the garage.**

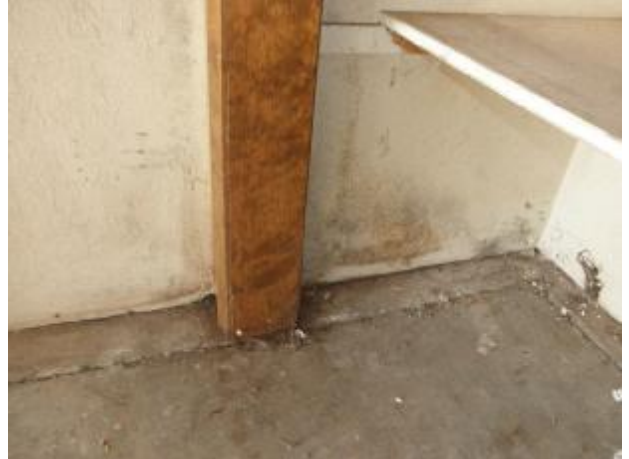
**Evidence of leaks with a black mildew like substance on the drywall inside the garage.**

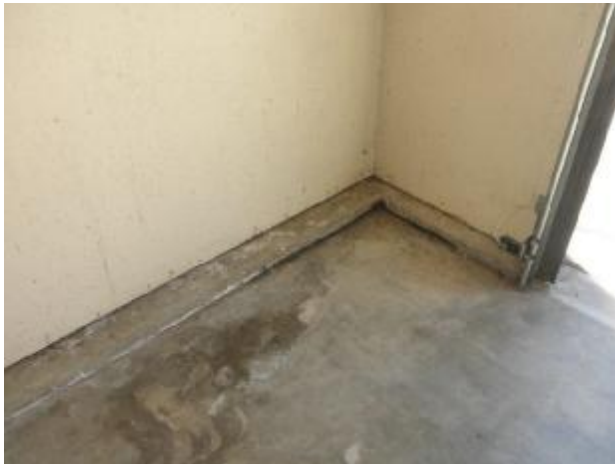
**Water intrusion at the interior SW corner of the garage.**

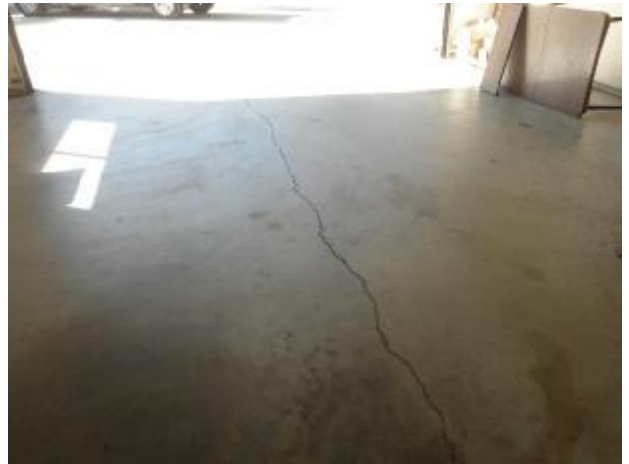
**General settlement crack in the garage concrete slab.**

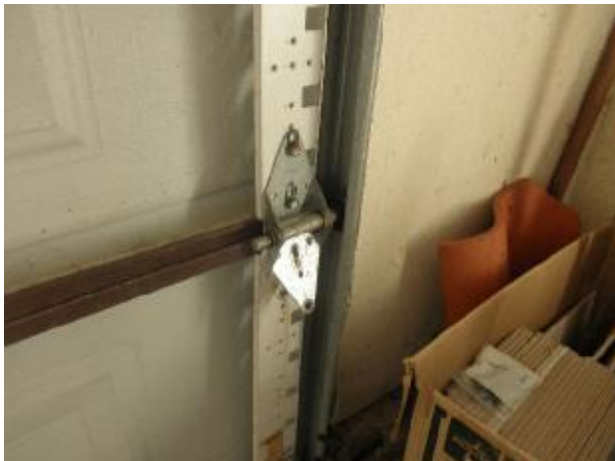
**Loose roller hinge at the garage door.**

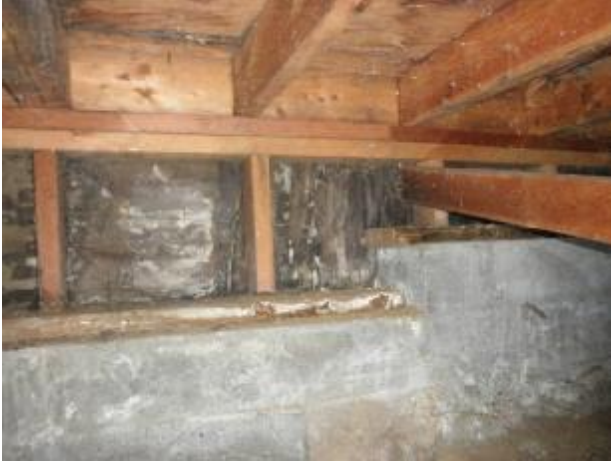
Fungus damage at the cripple wall and plywood subflooring in the substructure area.

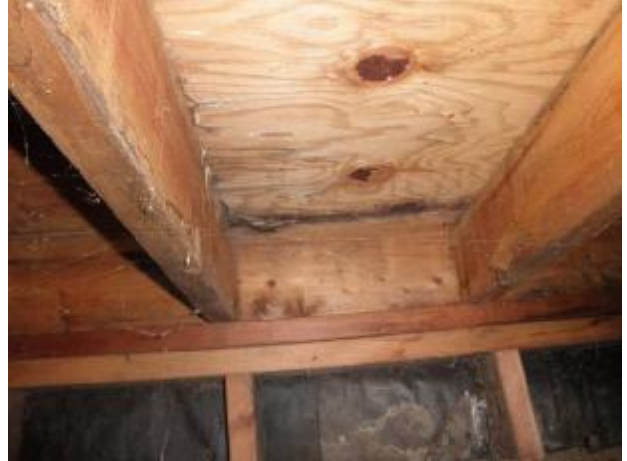
Fungus damage at the cripple wall and plywood subflooring in the substructure area.
